Llanteg Park

The Park was built in the 1970's as a set of holiday homes for people to enjoy with great views across the forest and sea, however despite being built with a common design and structure the past 40 years have meant that each home is now different from the next.

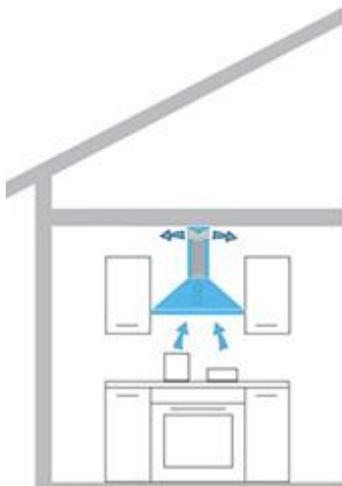
Kitchen hoods are often just recirculatory (i.e they just filter the air above the hob rather than extracting it). This means that the moisture is still in the house. So, don't just assume that because you have a hood that it is solving a condensation problem.

Circulation Hood

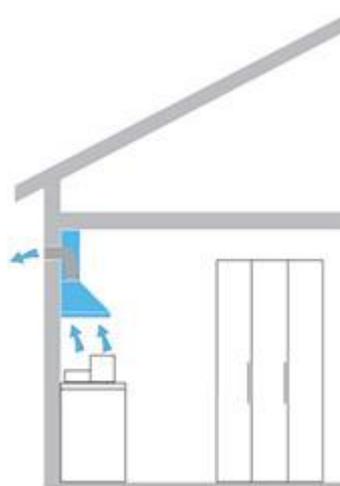
Extraction Hood

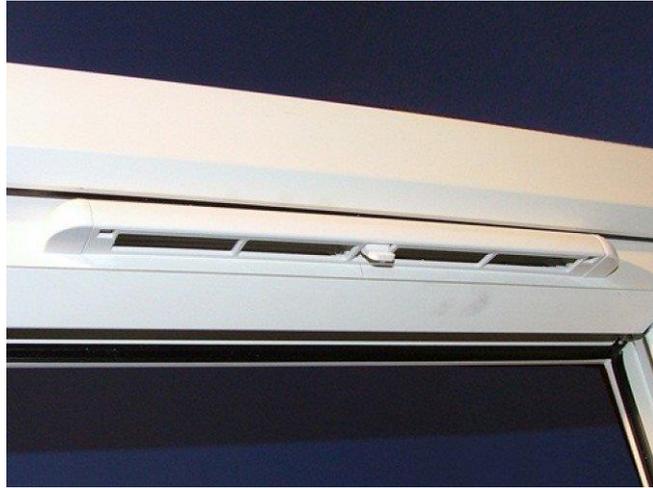
Whilst extractors are important for bathrooms and kitchens the rest of the house (and especially bedrooms) also needs to have some ventilation. This is typically done by 'trickle vents' in the windows.

Trickle vents need to be open and if they are not fitted they can be installed quite easily. If replacing windows then you will need to specify trickle vents otherwise they will not be fitted as standard.

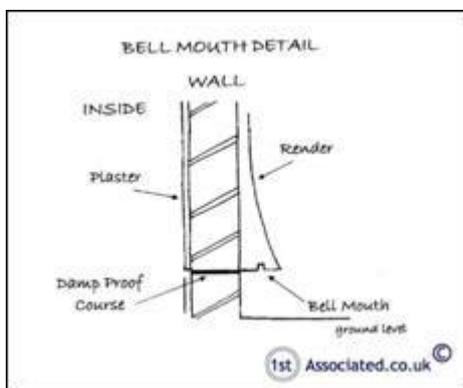
The DPC can be compromised (ie made not to work) by covering it over with render. If render goes down over the DPC and to the ground then water can travel up the render, over the DPC and into the main wall. So, it is really important that render is installed correctly and that drip beads (bell drips) are installed at DPC level.

From the diagram above you can see that the render should not be applied to the area underneath the bell mouth (drip bead) otherwise water can travel up the block and then through the render and above the DPC level.

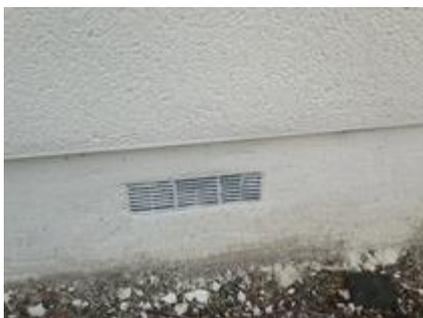
Where render goes all the way down the ground it can bridge the DPC, as shown below:
